(Rock County GRS Abutment Bridge on County Road 55)

State Aid Bridge News

January 2014

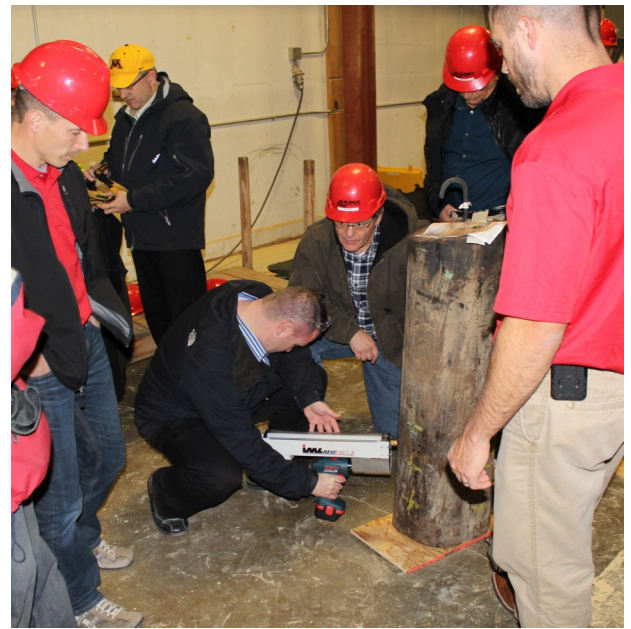
Advance timber inspection tools demonstration & training at Alamco Wood Products in Albert Lee, MN

Brian has summarized several models, advantages/disadvantages and costs for the advanced inspection tools. The two primary tools recommended include a stress wave timer and a resistance micro drill. These specialty tools are used to locate and quantify internal timber decay. There are continued discussions on how to fund the purchase of inspection tools and how to manage their availability for statewide use. As Brian initiates the development of the final research report, training, and inspection tool planning and implementation discussions will continue.

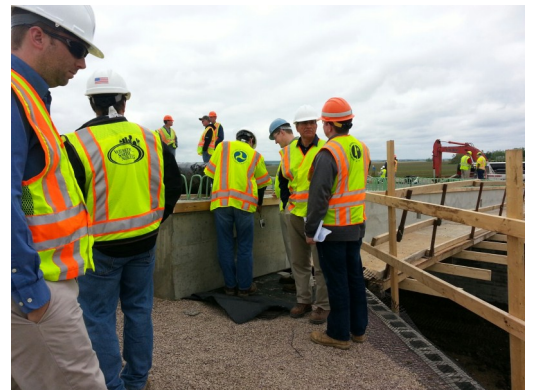
Through the FHWA's Every Day Counts initiative, GRS abutments are being rapidly deployed across the country, with about 100 in design or construction to date. GRS can reduce construction time, abutments can be constructed in three days, as compared to a week or more for a conventional concrete single line pile bent. No heavy equipment or specialized labor is needed. GRS can lower material and labor costs, with abutment cost savings of 25-60%. GRS can also potentially reduce maintenance costs, there are no bridge joints to maintain, the technology eliminates the bump at the end of the bridge, creating a smoother and safer transition, and GRS technology is extremely durable.

FHWA/MnDOT/Rock County GRS-IBS Showcase

With all of the excitement of Minnesota's first GRS abutment bridge, a national showcase was developed specifically for the Rock County GRS abutment bridge. The bridge was designed by Erickson Engineers, and constructed by Minnowa Construction, Inc. The showcase was developed by Rock County, SALT Bridge, MnDOT Foundations Office, and the FHWA. The showcase discussed GRS technology, performance, construction considerations, project overview, and included a field trip to the bridge site. The showcase drew around 40 participants from five states, mostly engineers. You can watch this [video](#) for a nice recap of the showcase and the advantages of GRS technology.

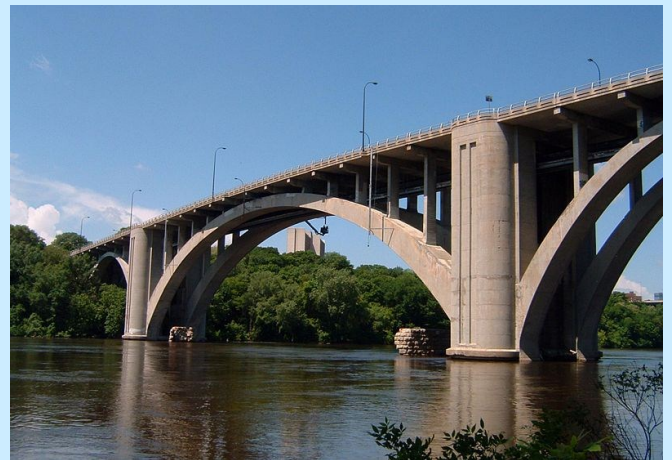
Franklin Avenue Bridge: Hennepin County Road 5 over West River Parkway and the Mississippi River in Minneapolis. The Franklin Avenue Bridge (also known as the Cappelen Memorial Bridge) was completed in 1923; the bridge was considered to have the longest concrete arch in the world. The bridge was added to the National Register in 1978, The Bridge's overall length is 1054.7 feet, with a central span of 400 feet. The bridge is scheduled for a \$21 million renovation by Hennepin County beginning next fall. The renovation will include a new deck, rebuilt railings, the installation of historically appropriate lighting, repaired arches and piers, and a widening of the east side of the bridge. The County has also proposed that the renovation include a redesign of the bikeway on the bridge, allowing for a protected cycle track.

Cappelen Memorial (Franklin Ave) Bridge

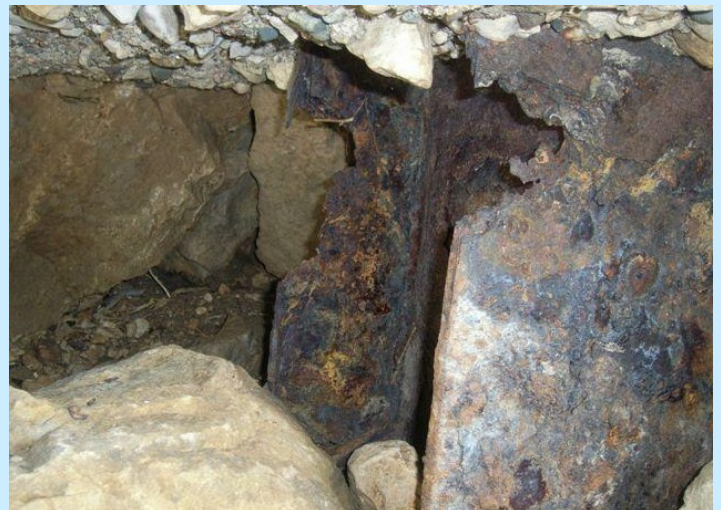
Winona County issues with deterioration of abutment pile. Photo shows corrosion eating away steel H piling under concrete abutment

In May of 2013 Winona County informed us of issues with deterioration of steel H piling under concrete abutments. According to Winona County, over the life of the bridge either the ground under the abutment settles, or it washes out and is filled back in, leaving an air/soil interface under the abutment and a place for pile corrosion and deterioration to take place. David Kramer, Winona County Engineer did a nice job documenting their corrosion problem, and a solution to protect future steel H piling from corrosion. Dave's steel H pile corrosion protection detail calls for encasing approximately 5' of H pile below the concrete abutment with a steel pile shell filled with concrete.

Until we heard from David Kramer, SALT Bridge & the Bridge Office were not aware of steel pile corrosion below concrete abutments. Ironically, about six months later pile corrosion resulted in failure and temporary closure of an interstate bridge in Wisconsin, and temporary closure of a state bridge in Duluth. Regarding our common Minnesota local bridge supported on steel H pile, any soil settlement and air voids below the concrete abutments are probably rarely seen because the riprap may be hiding the problem. Perhaps this concern might warrant us to look at our integral abutment details; possibly we should be providing additional soil cover at the base of the concrete abutment stem, and/or maybe some additional geotextile around the abutment stem to retain the soils better.

In 2010, Iowa looked at several highway bridges to determine the condition of steel abutment piles. Unfortunately, during the bridge inspections, they too observed corrosion at upper portions of steel piles, where erosion has created voids between the soil and the bottom of the abutment concrete. They noted that corrosion was significantly more severe at pile segments that were located above the grade line, compared to portions that were covered. In 2011, Iowa looked into some possible steel pile coating systems for lab and field testing. Coating systems such as bituminous mastic, non-shrink grout (pile encapsulation with grout), thermally sprayed aluminum coatings, etc. were identified for further evaluation. As stated above, the MnDOT Bridge Office will be looking into Iowa's past studies and reports, etc. to help formulate some statewide guidance in the near future on steel pile corrosion.

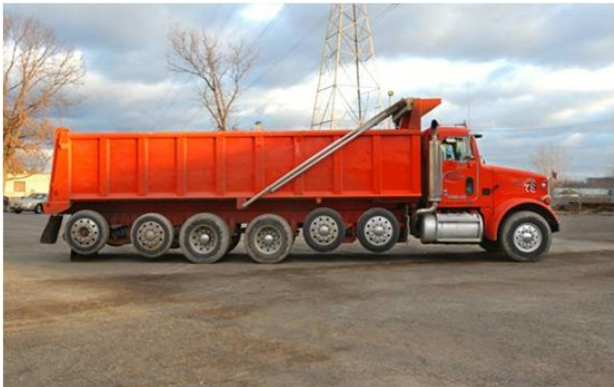
Specialized Hauling Vehicle, SU7 (Single Unit 7 Axles) Shown
